## **LAS PALOMITAS HOA**

***Level 2 Reserve Study Update (With Site-Visit)***

***Prepared For Fiscal Year 2024***

***November 16, 2023***

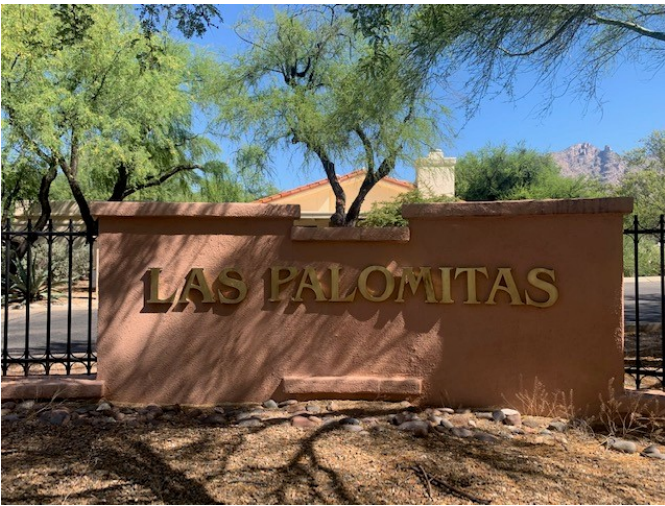
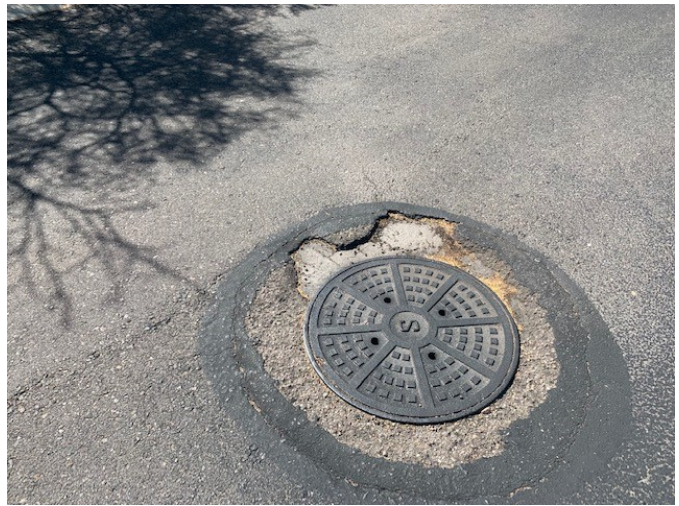
Asphalt cracks

Weather, traffic & time work to erode the asphalt pavement. The sun dries out the natural oils, while the unprotected surface is left to oxidize. The brittle blacktop surface cracks, allowing moisture penetration (the primary cause of pavement failure). A surface seal (sealcoat) fills in minor cracks & depressions that lead to larger ones. It also penetrates & resaturates the dried out surface with natural oils & solids to create a protective shield that guards the pavement from weathering & further deterioration. A sealcoat can substantially increase the pavements useful life expectancy. When the sealcoat starts to change from a deep black to a dull gray, it generally indicates that it's time to re-coat. Cracks in concrete driveway/curbs/gutters/sidewalks must be filled under an annual maintenance program to deter further deterioration due to erosion or sectional replaced with a base/pavement designed to prevent recurrence.

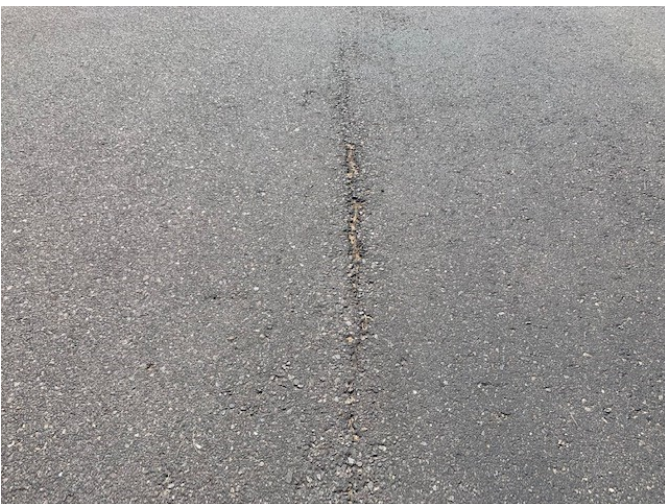
Isolated asphalt cracks

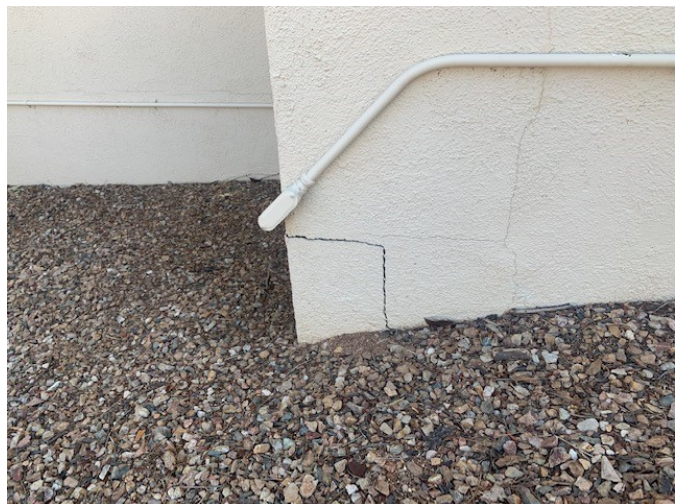
Crack in wall

Minimal care will keep a stucco surface attractive for many years. Cracks should be filled with a stucco patching compound to match the existing finish coat. This product is available in many colors at most building supply centers. Periodic pressure cleaning will keep the stucco clean & the finish coat bright for many years. In time, however, the stucco will eventually require recoat, paint or fog-coat application.

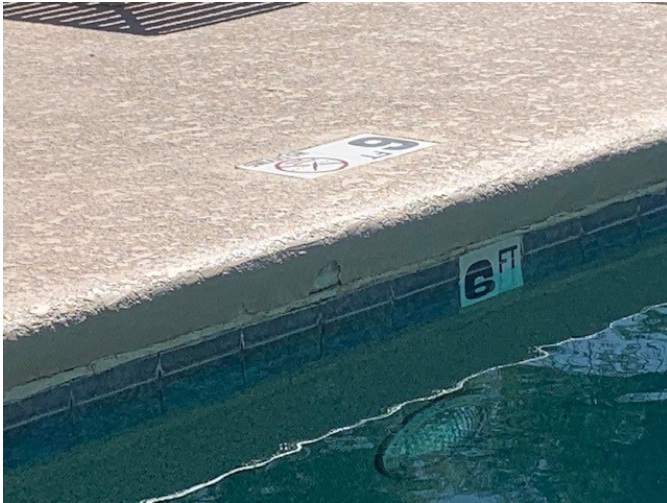
Pool decking delamination

All deck coatings require periodic maintenance. The time interval depends on coating life, traffic patterns & exposure to the elements. The deck surface must be inspected/repaired/sealed under an annual maintenance program to prevent water infiltration.

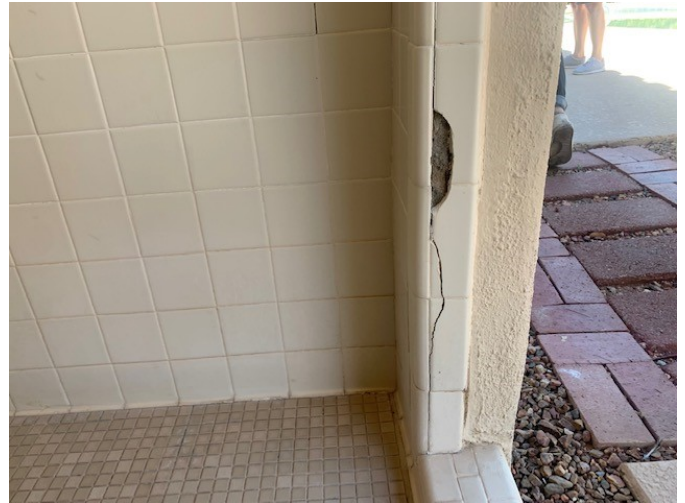
Cracked tile (A)
